Commonwealth of Massachusetts  
Department of Telecommunications and Energy  
Fitchburg Gas and Electric Light Company  
Docket No. D.T.E. 02-24/25  
Record Request Response

**Record Request No.: AG-RR-51**

**FG&E Electric Station Switchgear Failure  
March 12, 2000  
Event Analysis Report**

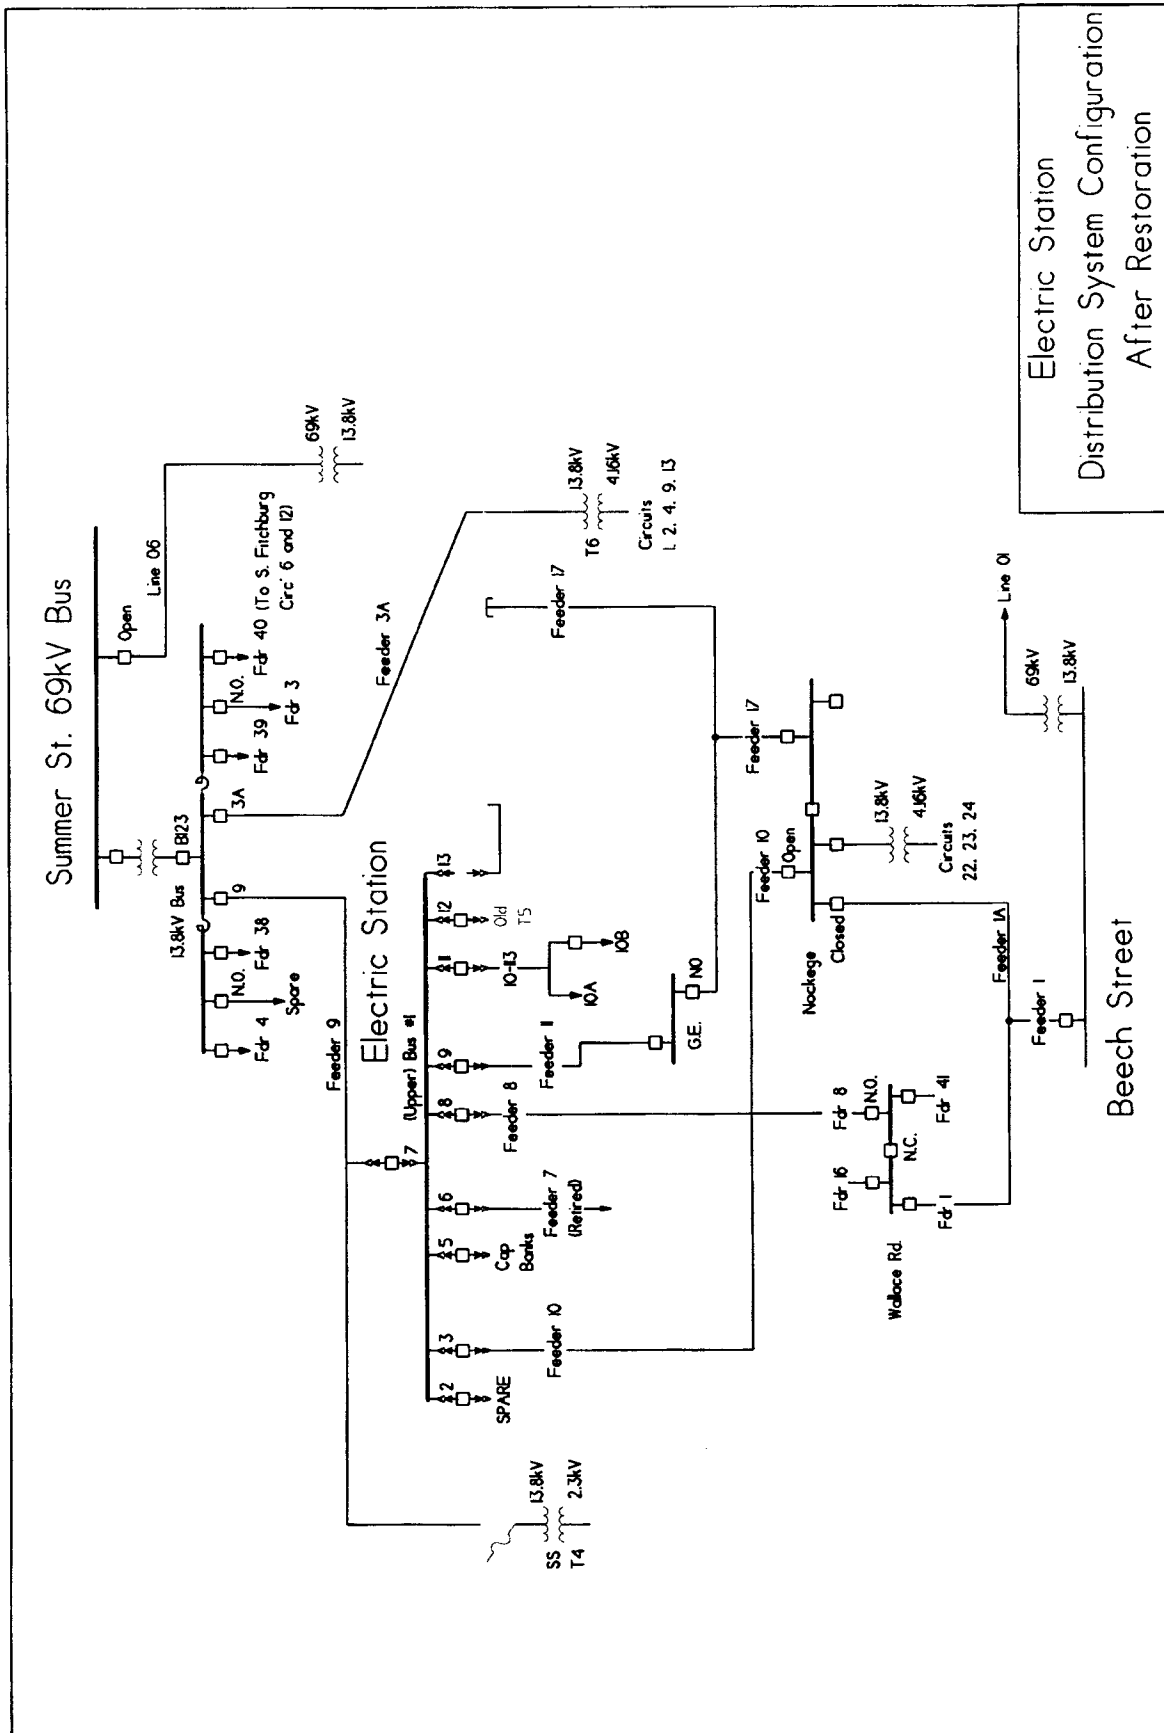
**Appendix C**  
**Electric Station Area configuration After Restoration**

Appendix C displays the temporary configuration of the system as it exists after the restoration. The system is left in this temporary configuration until more permanent repairs can be performed.
